## **THE BLUFFS AT EVERGREEN FIRE INVESTIGATION REPORT**

Insured: DH&G LLC  
Loss Location: 2 West Casino Rd.  
Everett, WA 98204  
Date of Loss: December 31, 2015  
File Number: 220.19486  
JH File Number: 1C0703257

JENSEN HUGHES was retained on January 6, 2016 and requested to investigate the origin and cause of a December 31, 2015 fire at the Bluffs at Evergreen apartment complex, located at 2 West Casino Rd., Everett, WA 98204.

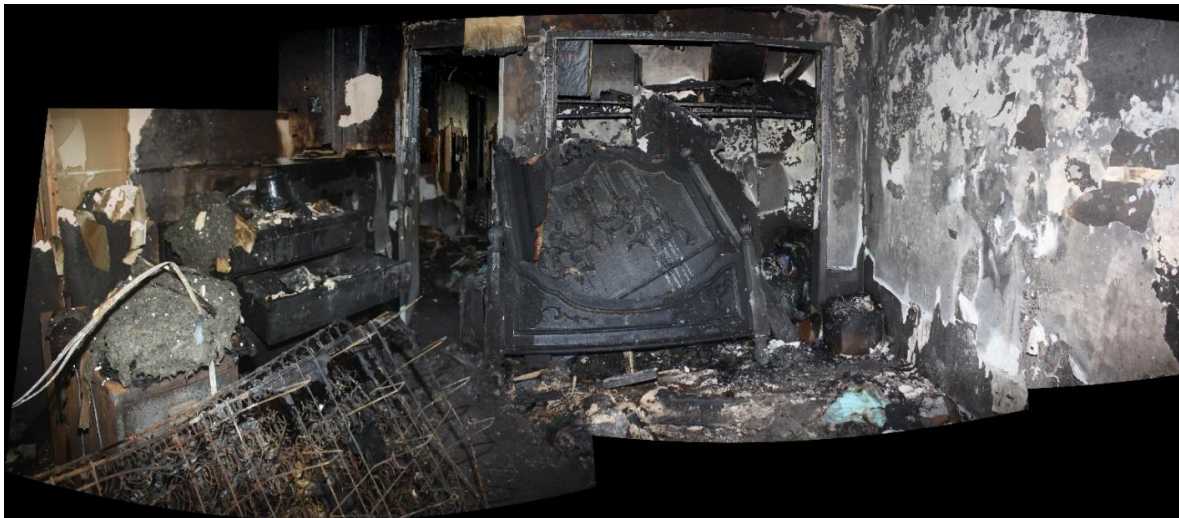
**Figure 5: Composite image of SE Bedroom, taken 01/08/16, view to north.**

2. Fire patterns in the southeast bedroom showed that the fire originated on the bed in the southeast quadrant. A fire-damaged wood base of a box spring foundation was found on the floor in this area. The box spring was a few inches away from the east and south walls. The fire damaged mattress and metal box spring frame were found leaning against furniture on the west wall. A view of the southeast bedroom is shown in Figure 4 and Figure 5.

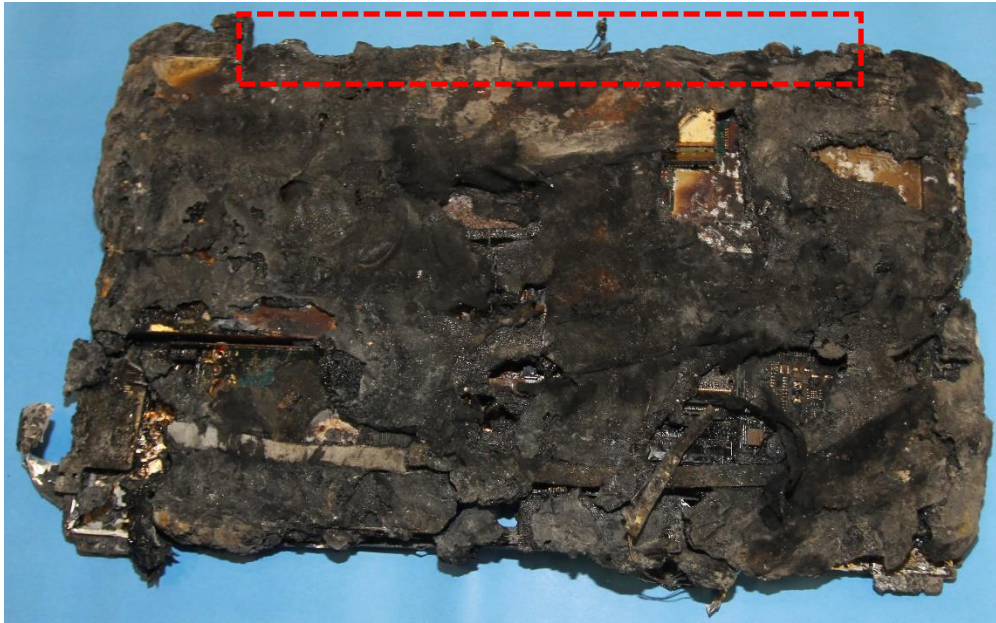
**Figure 11: IMG\_0016, SAS, 08/25/16: Underside of laptop. Location of battery pack indicated (red).**

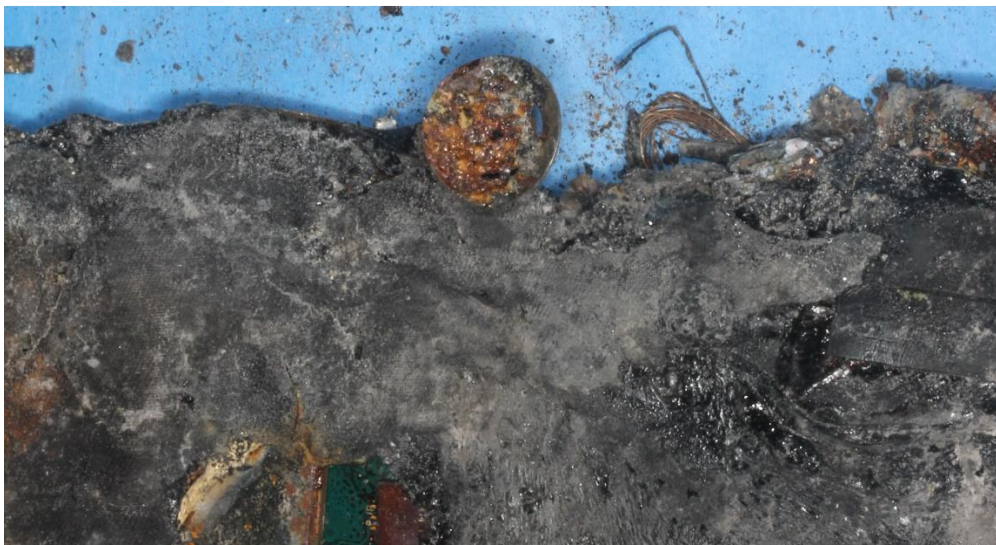
**Figure 12: IMG\_03012, SAS, 08/25/16: Li-ion battery cell top cap attached to laptop.**

- e. The cap was missing from one of the cells (Item #3, found outside) and the internal jellyroll was expelled when the cell explosively vented. The top cap matching this cell was found attached to the laptop battery pack / laptop remains. The other two cells still had the top caps attached.

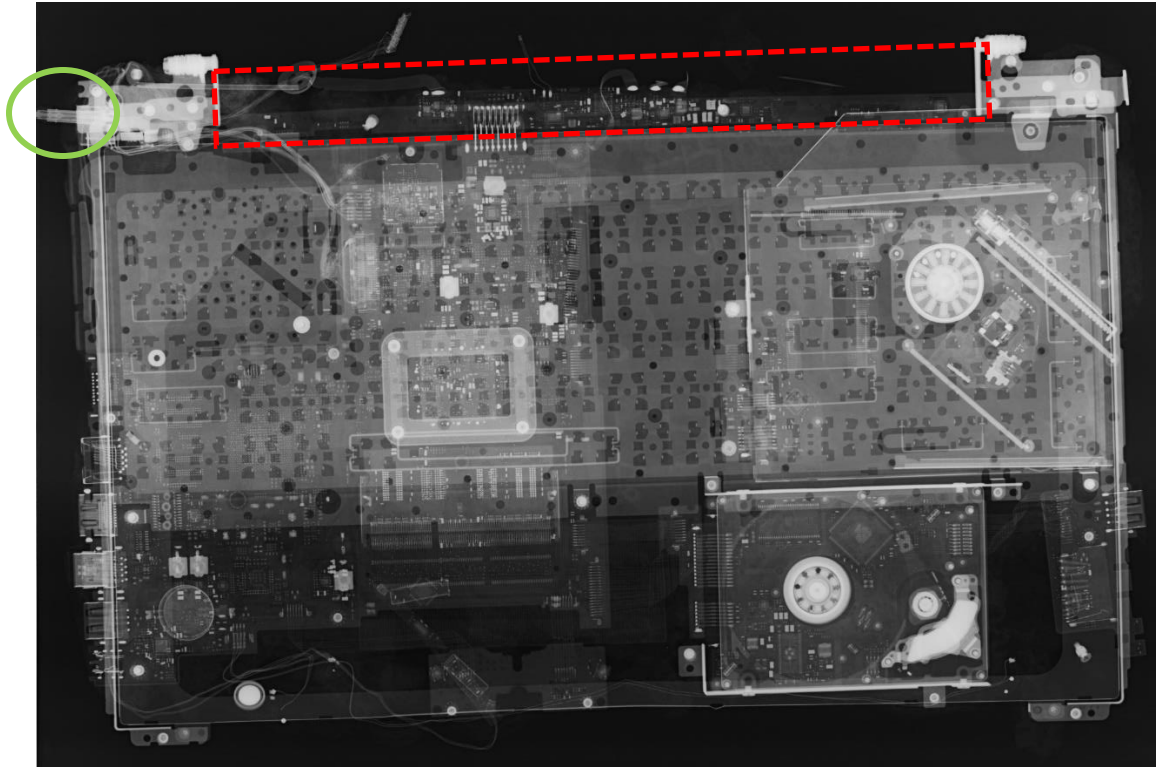
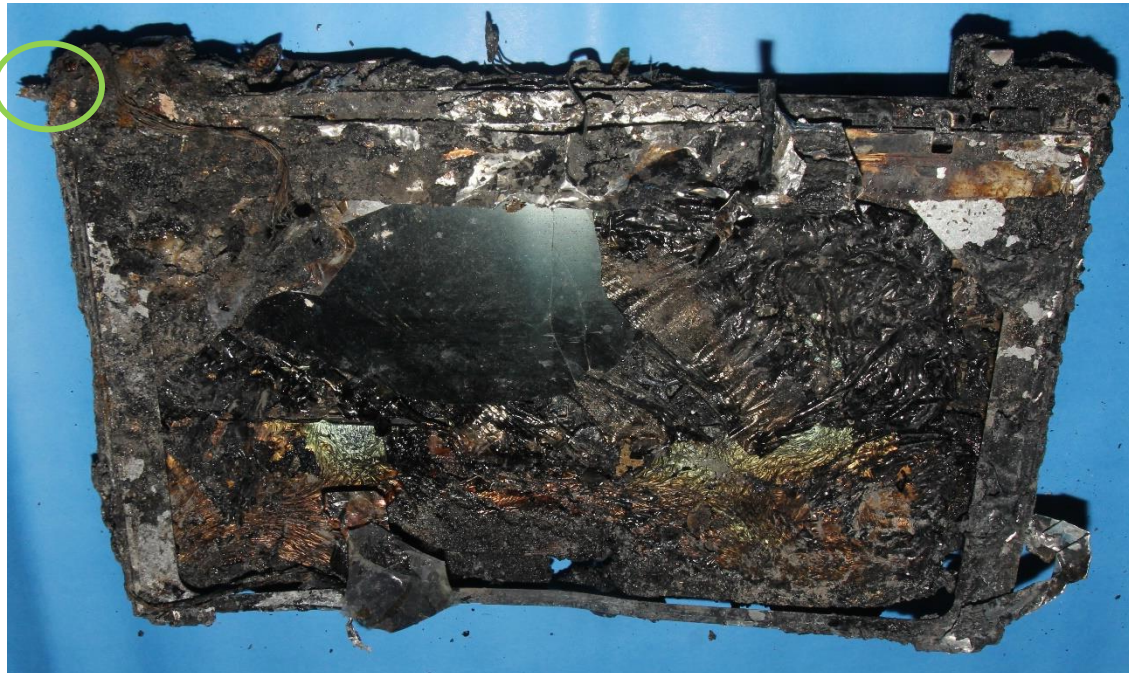
- d. The DC power plug, separated from the power cord, was found inserted into the laptop at the left rear corner (Figure 13 and Figure 14). This showed that the laptop was plugged in and energized at the time of the fire.

**Figure 13: X-ray of subject laptop. Battery pack indicated in red, and charging port with DC plug inserted in green.**

**Figure 14: IMG\_0023, SAS, 08/25/16: Laptop with DC plug inserted into the charging port.**

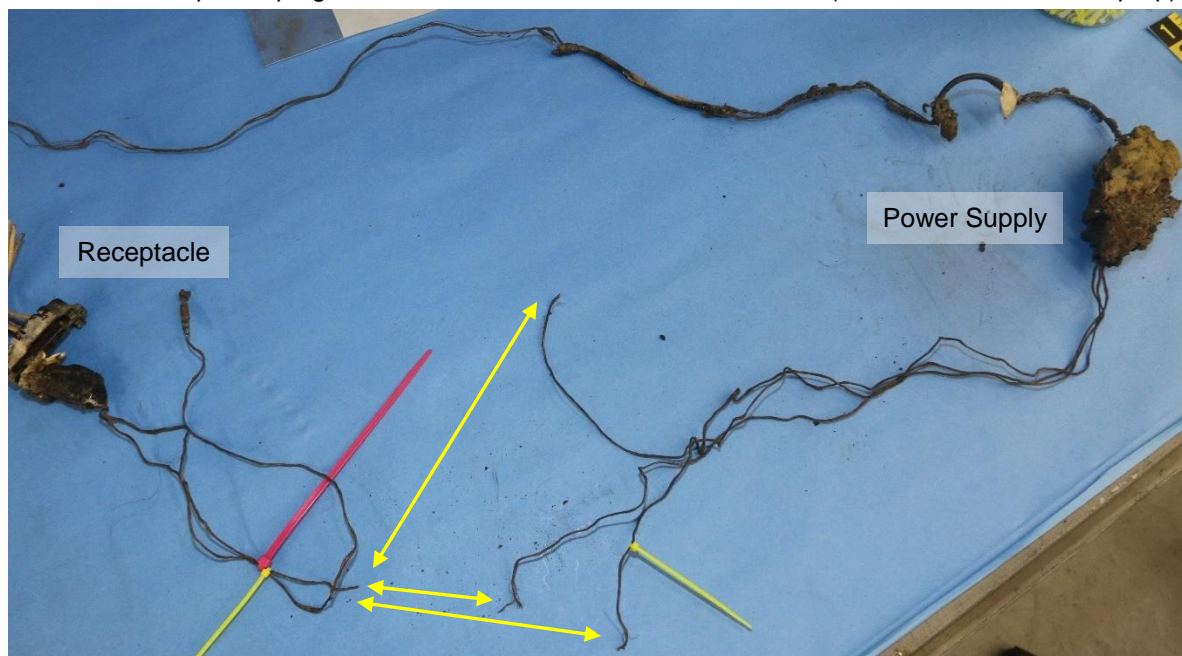
- ii. The line cord was fire damaged and much of the insulation was burned away. The line cord was severed approximately 11.5-inches from the receptacle. The severed ends showed evidence of melting and beading indicative of electrical arcing.

**Figure 17: IMG\_0035, SAS, 03/20/16: Laptop power supply, receptacle, and arc-severed line cord.**
